Lessons From a Buffalo

In July 2012, while TIGHAR was searching the reef at Nikumaroro for the wreckage of NR16020, a NOAA Maritime Heritage team at Midway Atoll was documenting and identifying aircraft wreckage discovered in May.

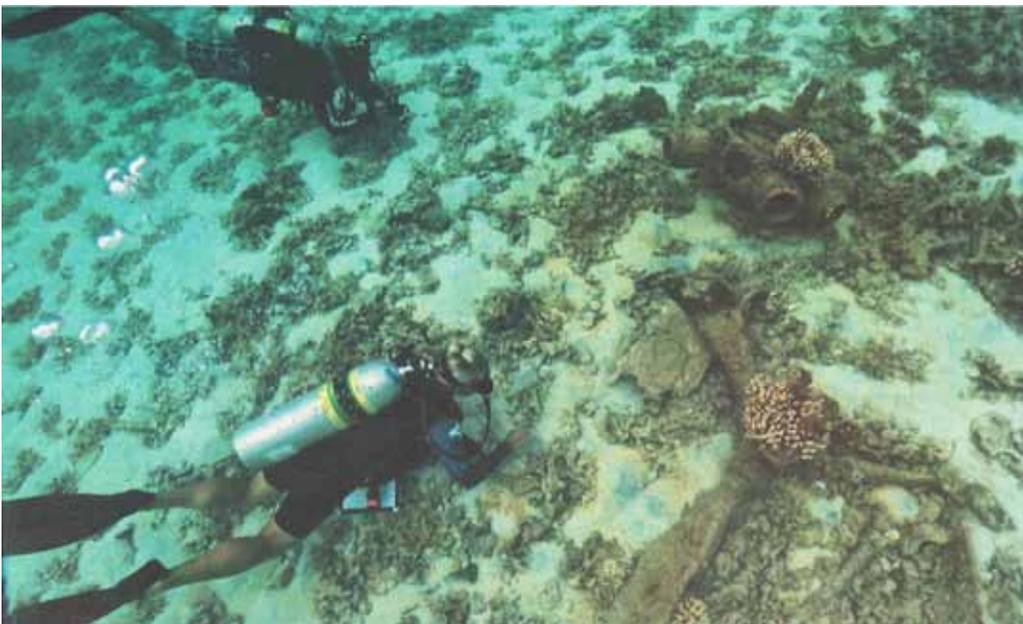
NOAA Maritime Heritage archaeologists documenting the propeller and engine from a Brewster F2A-3 "Buffalo." Open Boat Films/NOAA/Stephani Gordon.

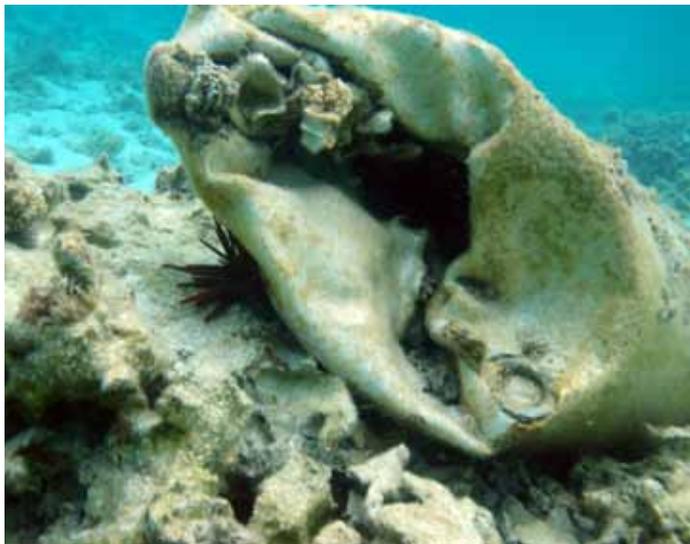
The aluminum skin of the Buffalo's tail cone appears free of any significant coral growth or corrosion. NOAA/Cathy Green.

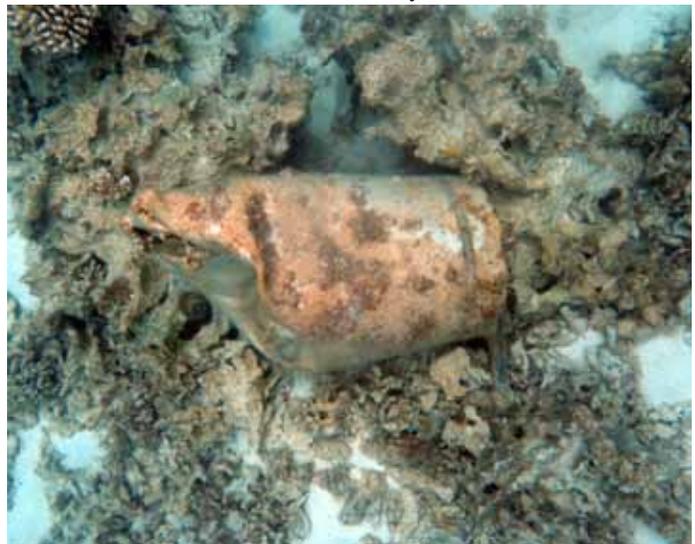
The tail cone was apparently torn loose as the aircraft flipped inverted. The tail wheel was found at the opposite end of the debris field. NOAA/Cathy Green.

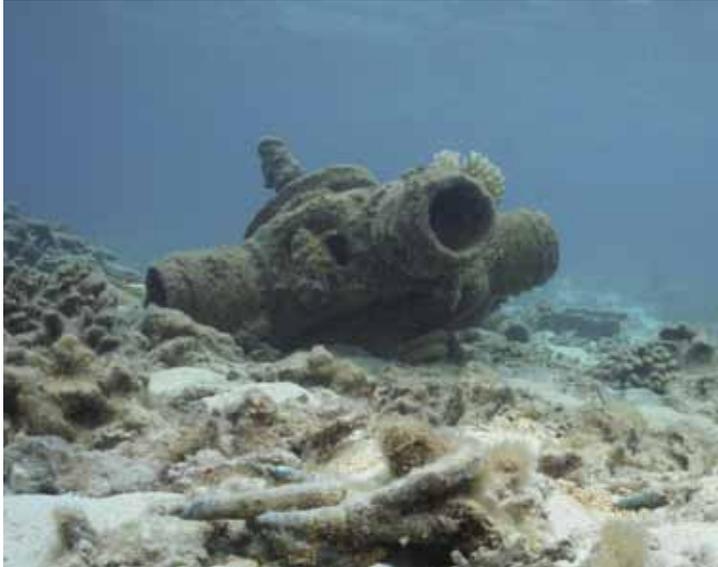
Most of the engine is missing. NOAA/Bert Ho.

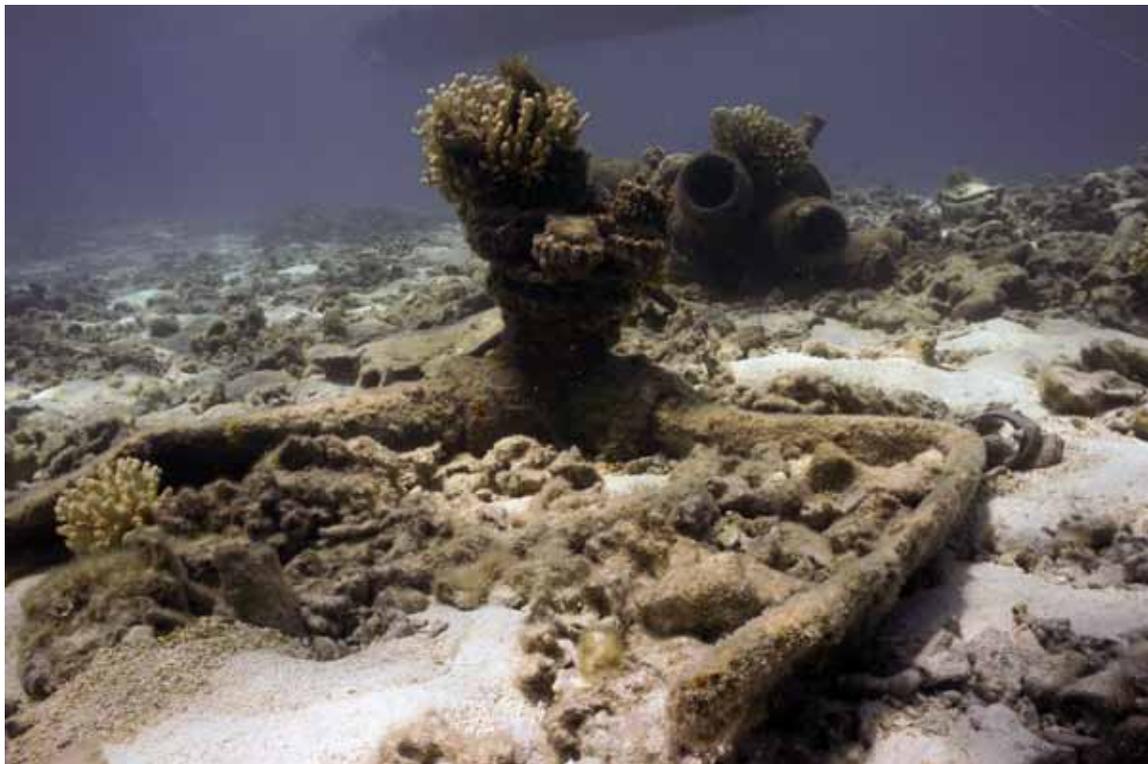
The propeller shows the effects of striking the bottom during the crash. NOAA/Bert Ho.
